201900001  
January 2, 2019

## Property Condition Assessment (ASTM E 2018-15)

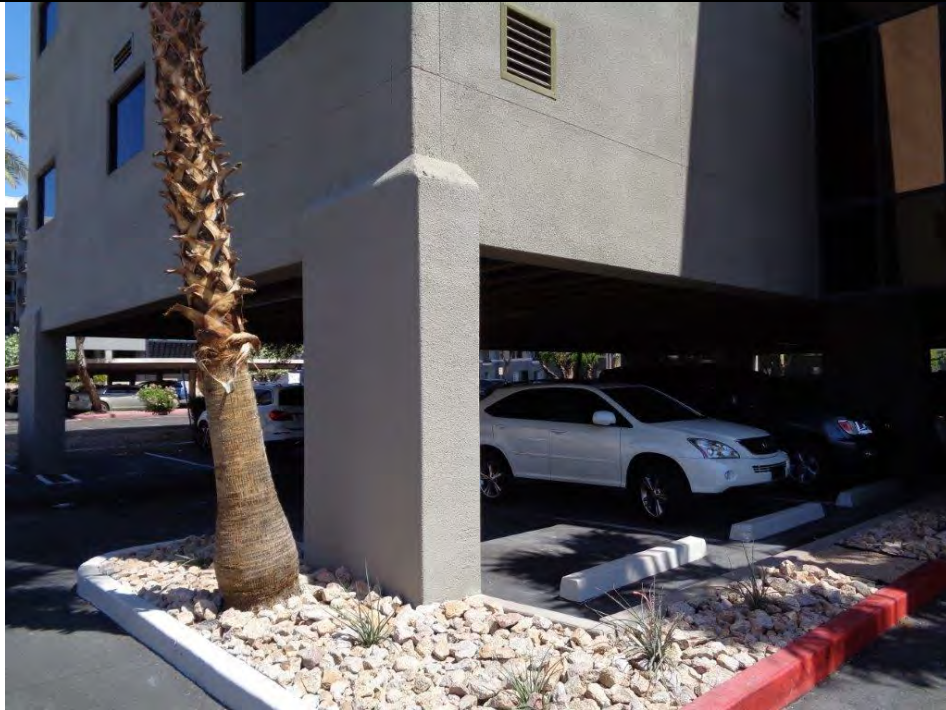
Concrete column supporting tuck-under parking area

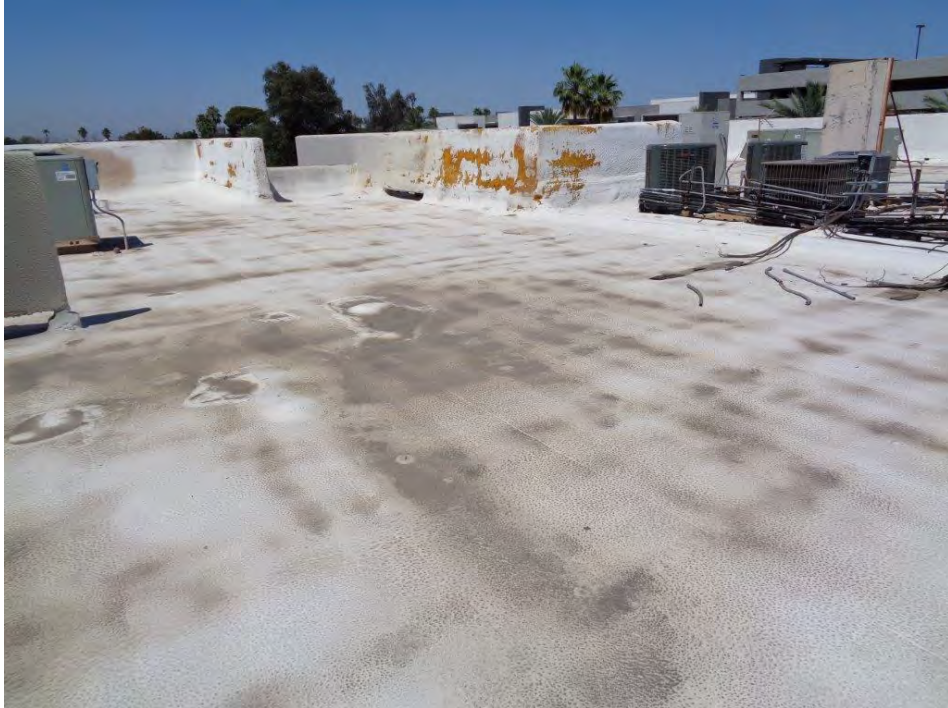
Typical roof surface

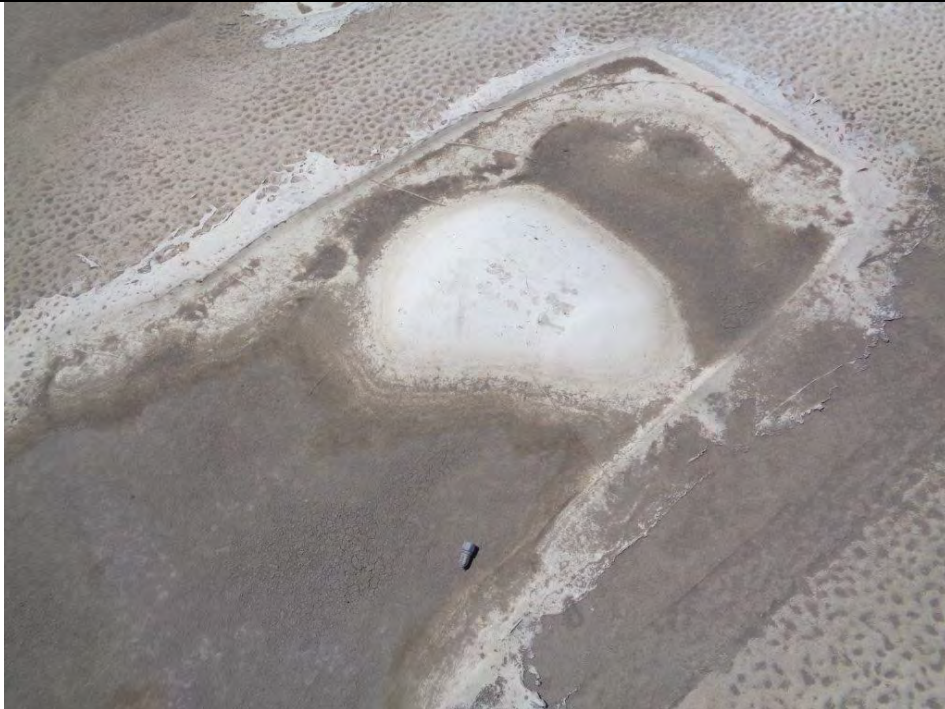
Typical "pillowing" observed

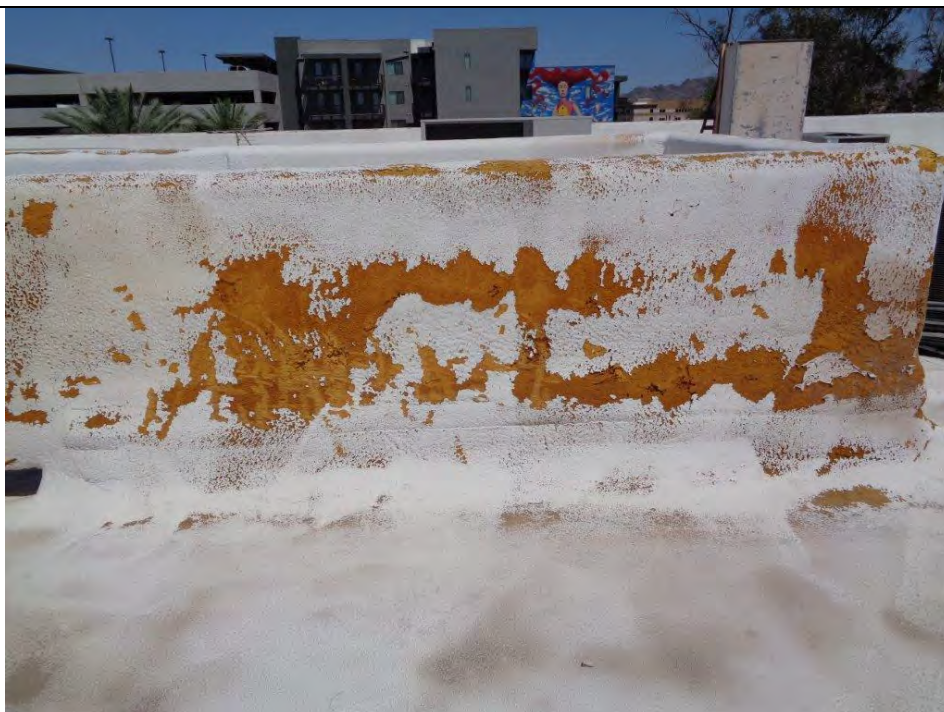
Typical foam degradation

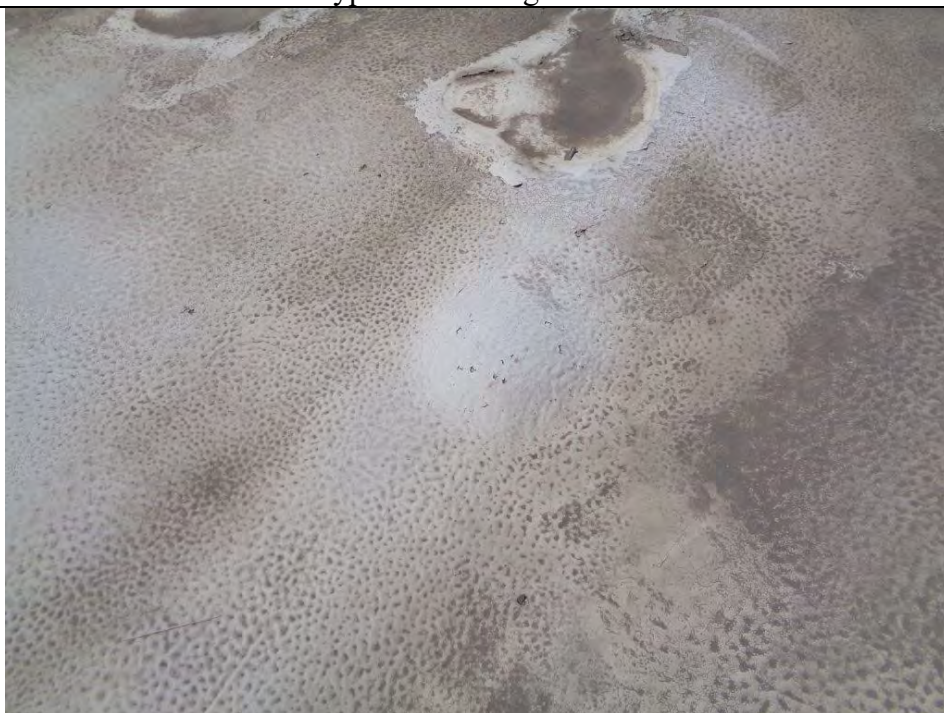
Typical "pillowing" observed

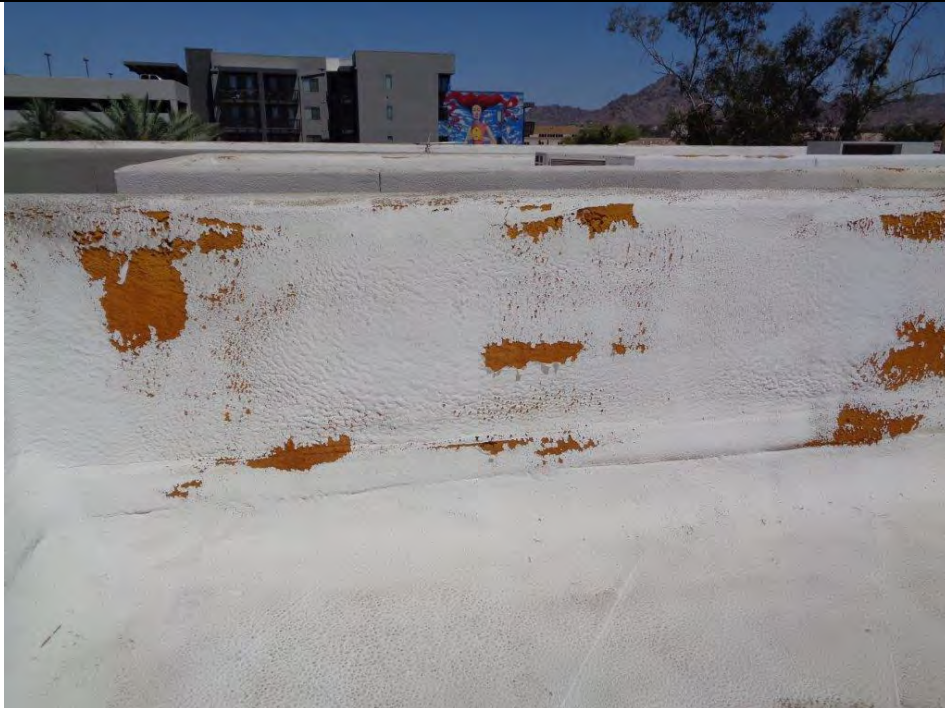
Typical foam degradation and delamination

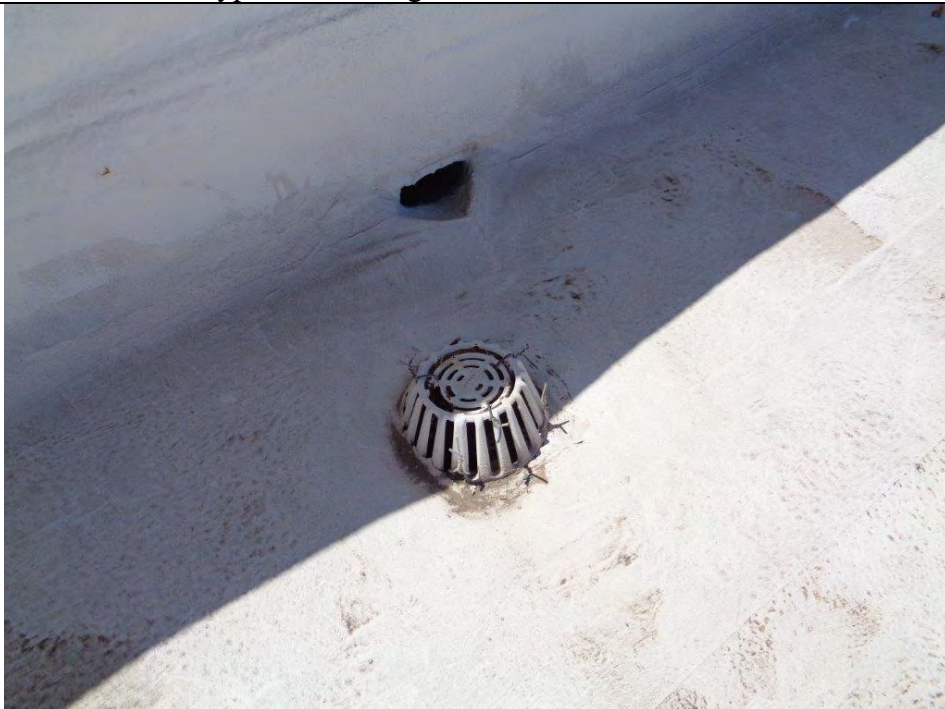
Typical roof drainage

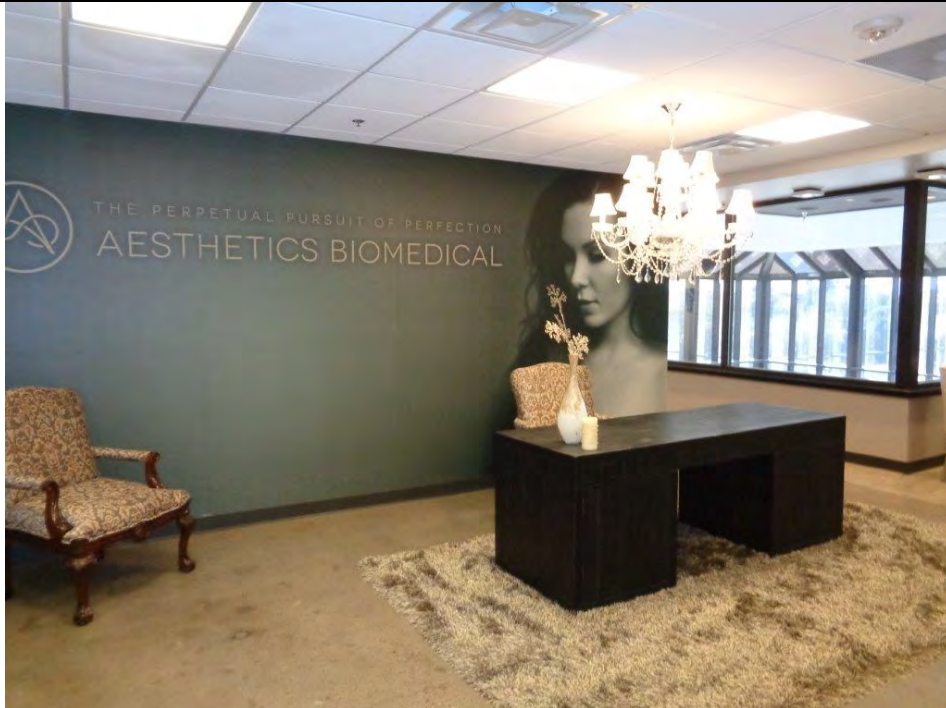
Typical interior finishes

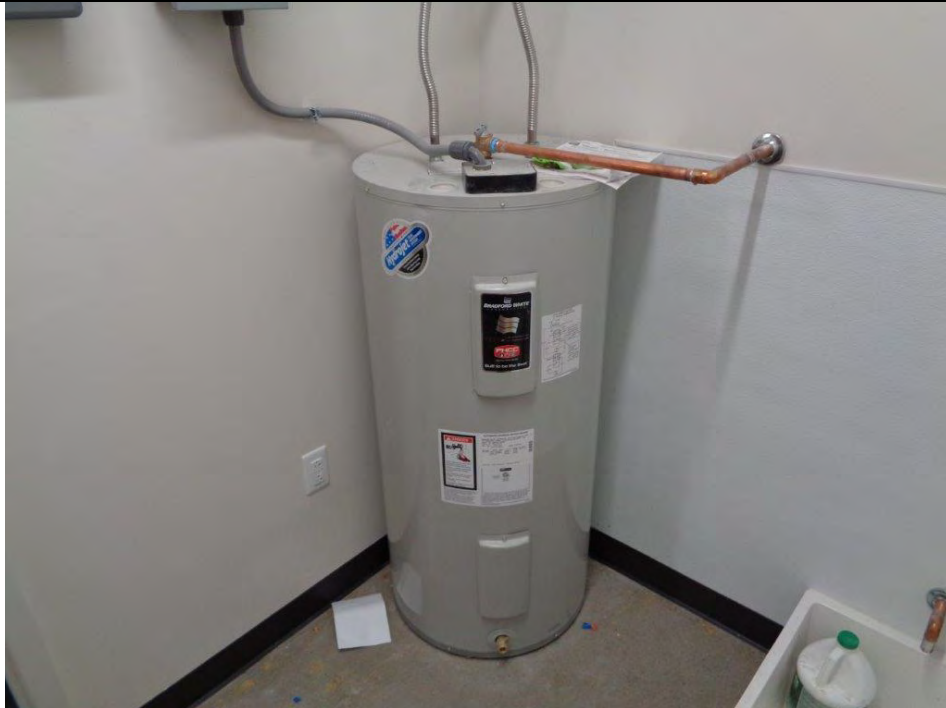
**PLUMBING, HVAC, ELECTRICAL and ELEVATORS**

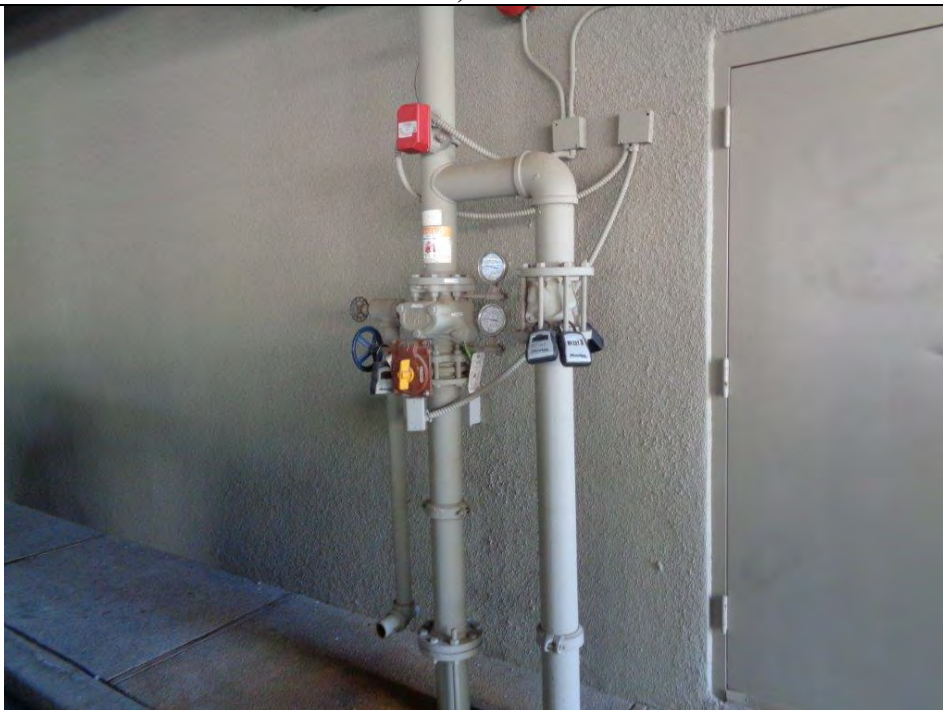
**LIFE SAFETY, ADA and MOLD**
